RUBINOFF PROSTHODONTICS

SHITE HAPPENS!
Sometimes, you have to
change the game plan to
accommodate
catastrophic change!

Case History: 2001 Treatment

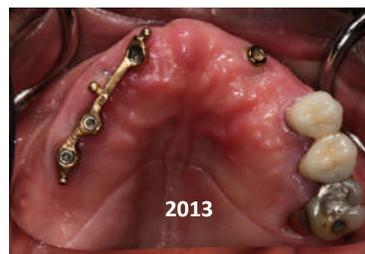
A great island get away turned into a dental disaster. Our patient developed a problem while on vacation resulting in the fracture of his anterior denture teeth #12,11,21,22,23). With the help of a local dentist and "crazy glue", the anterior tooth alignment was altered. When the holiday was over, our patient returned to my office for definitive prosthodontic care. Our patient had significant financial concerns. **What can be done that will utilize existing prosthetics to decrease costs? How will we stabilize the dentition in lieu of all of the biomechanical changes in the dentition?**

- Endodontic referral for abutment #25
- Crowns #24,25 & post #25
- Locator abutment #22 site
- New fixed\detachable prosthesis in maxilla using alternative stud snaps for improved retention (red snaps due to metal wear on gold alloy snaps).

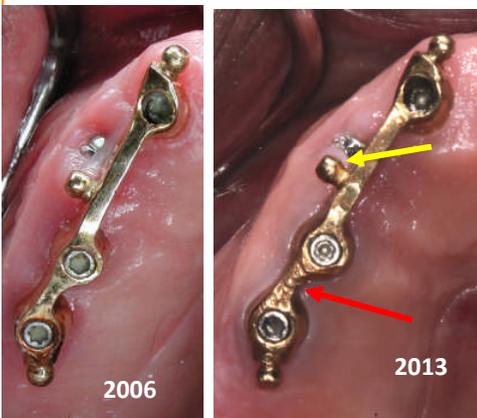
2006

2013

If you look closely, you will definitely see metal wear between 2006 and 2013. This is a result of the cast chrome cobalt metal housing wearing down the bar (see red arrow) and the yellow nylon stud snaps wearing down the round studs (see yellow arrow).

Time can take its toll on metals. The metal bar made of a gold alloy in 2001 has undergone wear and the yellow stud snaps (even new ones) fit loosely. By changing to a tighter fitting stud snap (red color), the frictional retention is significantly improved.

In my practice, we **now** use a "semi precious" alloy with a Vickers Hardness of 300. I recommend Argelite 71 by Argen. Dentists who use a popular high gold content alloy (such as Design 91 by Ivoclar) have a Vickers Hardness of only 250. Bego sells a popular non precious alloy made of chrome cobalt (no nickel or beryllium) with a Vickers Hardness of only 280. **For those using titanium alloy** (Ti-6Al-4V) as a milled or cast bar, the Vickers harness is even higher (350-369 if the metal is annealed during treatment).

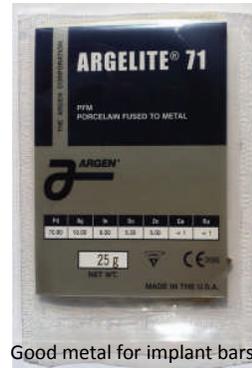
Good metal for implant bars

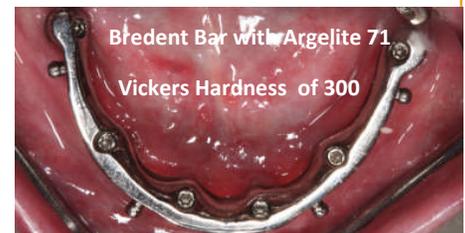
Bredent Bar with Argelite 71

Vickers Hardness of 300

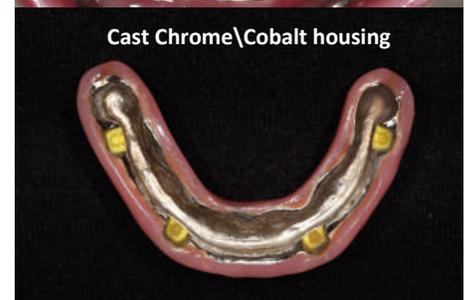
Cast Chrome\Cobalt housing
