Long term marriages in Dentistry –Part Two

RUBINOFF PROSTHODONTICS

Volume 2, Issue 15

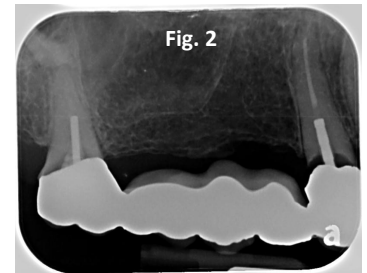
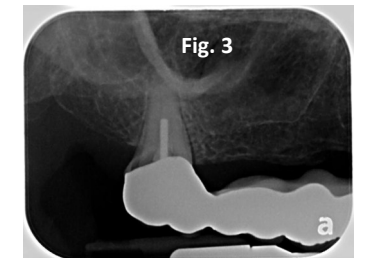
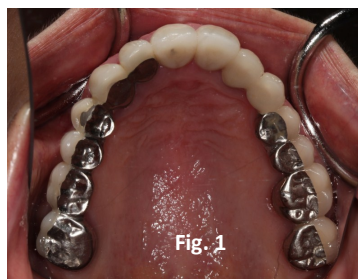
Fig. 1 illustrates the maxillary occlusal scheme. Jane has already fractured some of the porcelain on incisal edges. Radiographs confirm advanced dental caries in this region. (Fig. 2,3,4,5))

Jane’s reason for presentation after a long absence is due to the fractured porcelain on the upper right side and a loose upper right bridge & caries lower left side (Fig. 6,7,8)

The span of the pontic area is too long. Jane did not wish to have dental implants placed in the edentulous region (or a removable partial denture) when the original bridge was fabricated 20 years ago. Even though we double abutted the anterior teeth #12,13, the edentulous span was still too long. Occlusal forces may have resulted in loosening of the bridge with subsequent caries that formed in the area.

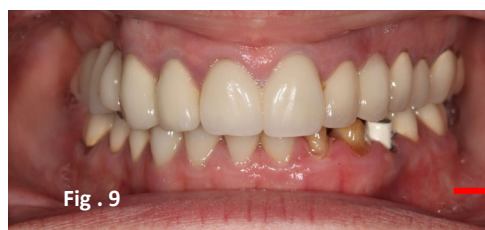
Fig. 11

The culprit is "Bundle Bone". No matter how good a surgeon we are, there will always be loss of some of the buccal plate (Bundle Bone) following tooth extraction. To avoid loss of buccal bone, it is usually recommended that we wait 2 to 3 months after tooth extraction before the dental implants are placed ("delayed implant placement"). Whether "ridge augmentation" or "socket preservation" is completed at the time of tooth extraction, we will still lose the bundle bone. To avoid bone loss around dental implants, the following technique is suggested in fresh extraction sockets. (Fig. 11)

Simultaneous placement of dental implants into extraction sockets often results in loss of buccal bone around implants!

Simultaneous Extraction and Implant Placement. The Technique:

- ◆ Consider flapping the buccal tissues to expose possible bone fenestrations and to aid in placement of collagen membranes
- ◆ Offset the center point of the pilot drill toward the lingual plate leave room for bone augmentation on the buccal wall both within the socket and external to the buccal plate.

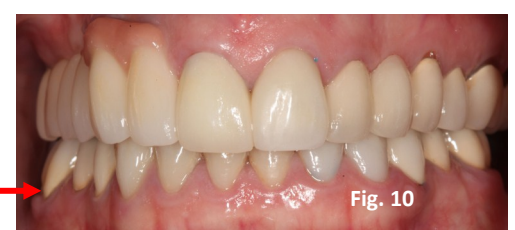
Fig. 12

Dentists must avoid placing the dental implant directly into the middle of the tooth socket or they may see an end result as in Fig. 12.

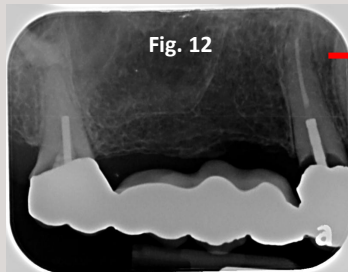
Fig. 12

- ◆ Placement of a fixed partial denture from #17 to #12 with pontics #16,15 and implant abutments #17,14,13,12
- ◆ Crown lengthening on #11
- ◆ Single "all ceramic" crown on #11
- ◆ Application of pink porcelain for aesthetic reasons in region of #12,13,14

Fixed Bridge:

Implants at: #17,14,13,12

Pontics at: #16,15

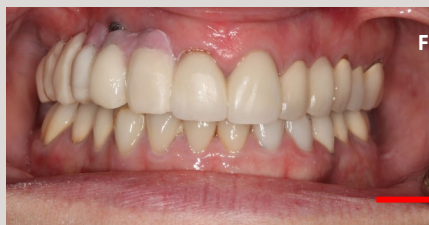
Fig. 15

Testing the addition of pink acrylic in the temporary bridge and adding pink porcelain in the final bridge. (Fig. 15)

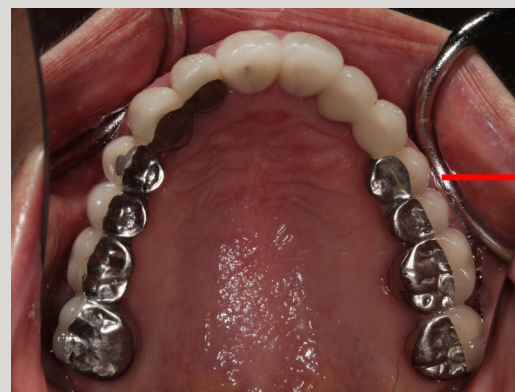
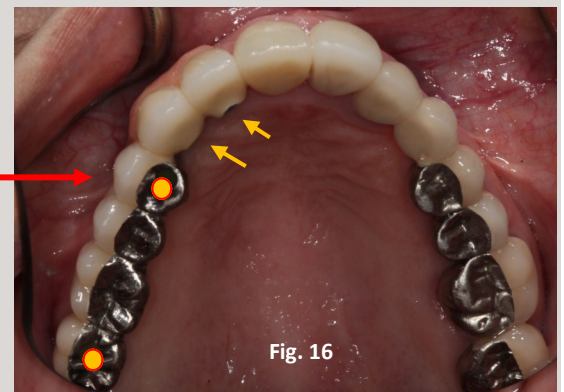
Fig. 16

- Occlusal screw access channel
- ➔ Lingual set screw access channel
